## Release Notes for DrayTek Vigor2862 series (UK/Ireland)

Firmware Version	3.9.4.1_BT (Formal Release)
Release Type	<b>Regular</b> – Upgrade recommended when convenient
Build Date	10 <sup>th</sup> August 2020
Release Date	3 <sup>rd</sup> September 2020
Revision	
Applicable Models	Vigor2862, Vigor2862n, Vigor 2862Ln, Vigor2862ac, Vigor 2862Lac, Vigor 2862Vac
VDSL Modem Code	779517
ADSL Modem Code	773F01
Locale	UK & Ireland Only

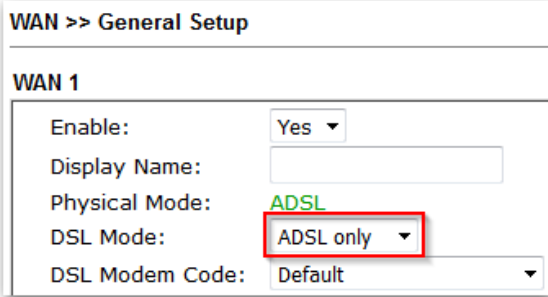
1. If experiencing an issue establishing an Internet connection on ADSL or ADSL2+ connections, set the WAN1 DSL Mode to “ADSL Only”
