## Release Notes for DrayTek Vigor 3910 (UK/Ireland)

Firmware Version	4.3.2.9 – Mainline branch (Formal Release)
Release Type	<b>Critical</b> – Upgrade recommended immediately
Build Date	12 <sup>th</sup> November 2024
Release Date	13 <sup>th</sup> December 2024
Revision	373_4242_bf211b6
Applicable Models	Vigor 3910
Locale	UK & Ireland Only

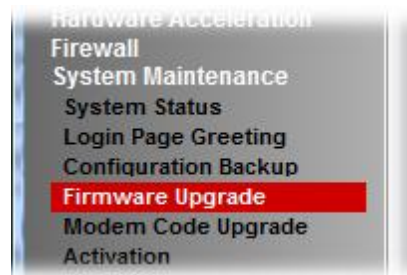
To upgrade firmware, select '*firmware upgrade*' from the router's system maintenance menu and select the correct file. Ensure that you select the ALL file unless you want to wipe out your router's settings back to factory default.
