## **Release Notes for DrayTek Vigor 2710 (UK/Ireland)**

Firmware Version	3.7.1
Release Type	<b>Regular</b> – Upgrade recommended when convenient
Release Date	5 <sup>th</sup> March 2018
Build Date	5 <sup>th</sup> February 2018
Revision	71752
Applicable Models	Vigor2710, Vigor2710n, Vigor2710Vn, Vigor2710VDn
ADSL Modem Code	2471201
Locale	UK Only / Annex A Only

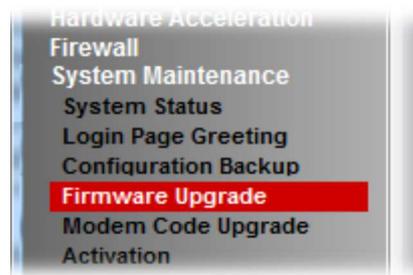
To upgrade firmware, select '*firmware upgrade*' from the router's system maintenance menu and select the correct file. Ensure that you select the ALL file unless you want to wipe out your router's settings back to factory default.
