## **Release Notes for DrayTek VigorAP 900 (UK/Ireland)**

Firmware Version	1.2.7
Release Type	<b>Regular</b> - Upgrade recommended when convenient
Release Date	27 <sup>th</sup> May 2021
Build Date	30 <sup>th</sup> August 2019
Revision	r10962
Applicable Models	VigorAP 900
Locale	UK Only

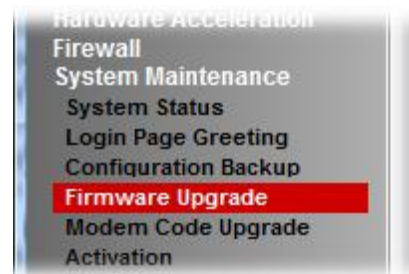
To upgrade firmware, select '*firmware upgrade*' from the AP's system maintenance menu and select the correct file. The access point will perform the upgrade and automatically reboot once this completes.

It is recommended that you take a configuration backup prior to upgrading the firmware. This can be done from the AP's system maintenance menu.
