Release Notes for DrayTek Vigor2762 series (UK/Ireland)

Firmware Version	3.9.1_BT (Formal Release)
Release Type	Regular – Upgrade recommended when convenient
Build Date	24 th July 2019
Release Date	7 th August 2019
Revision	83568
Applicable Models	Vigor2762, Vigor2762n, Vigor2762ac, Vigor 2762Vac
VDSL Modem Code	779517
ADSL Modem Code	773F01
Locale	UK & Ireland Only

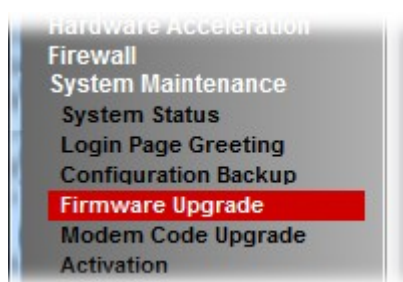
To upgrade firmware, select '*firmware upgrade*' from the router's system maintenance menu and select the correct file. Ensure that you select the ALL file unless you want to wipe out your router's settings back to factory default.
