Release Notes for DrayTek Vigor2762 series (UK/Ireland)

Firmware Version	3.9.2_BT (Formal Release)
Release Type	Regular – Upgrade recommended when convenient
Build Date	26 th November 2019
Release Date	15 th January 2020
Revision	86755
Applicable Models	Vigor2762, Vigor2762n, Vigor2762ac, Vigor 2762Vac
VDSL Modem Code	779517
ADSL Modem Code	773F01
Locale	UK & Ireland Only

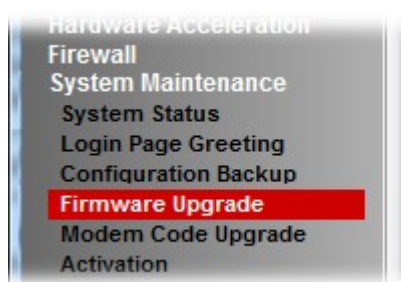
To upgrade firmware, select '*firmware upgrade*' from the router's system maintenance menu and select the correct file. Ensure that you select the ALL file unless you want to wipe out your router's settings back to factory default.
