## **Release Notes for DrayTek Vigor2762 series (UK/Ireland)**

Firmware Version	3.9.9.1_BT (Formal Release)
Release Type	<b>Critical</b> – Upgrade recommended immediately
Build Date	12 <sup>th</sup> September 2024
Release Date	16 <sup>th</sup> October 2024
Revision	21269_1188_af65f491c2
Applicable Models	Vigor2762, Vigor2762n, Vigor2762ac, Vigor 2762Vac
VDSL Modem Code	779517
ADSL Modem Code	773F01
Locale	UK & Ireland Only

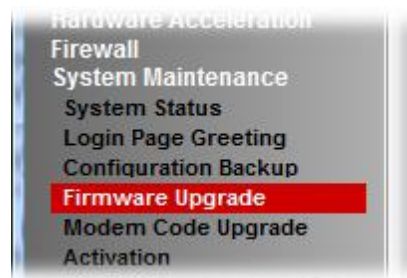
To upgrade firmware, select '*firmware upgrade*' from the router's system maintenance menu and select the correct file. Ensure that you select the ALL file unless you want to wipe out your router's settings back to factory default.
