## Release Notes for DrayTek Vigor2862 series (UK/Ireland)

Firmware Version	3.9.9.2 (Formal Release)
Release Type	<b>Regular</b> – Upgrade recommended when convenient
Build Date	18 <sup>th</sup> July 2023
Release Date	23 <sup>rd</sup> August 2023
Revision	17151_1116_ed90019452
Applicable Models	Vigor2862, Vigor2862n, Vigor 2862Ln, Vigor2862ac, Vigor 2862Lac, Vigor 2862Vac
VDSL Modem Code	779517
ADSL Modem Code	773F01
Locale	UK & Ireland Only

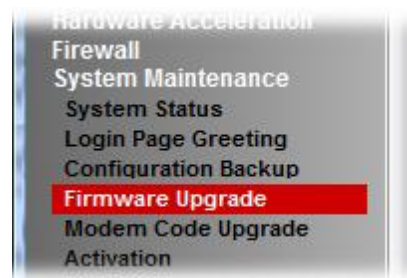
To upgrade firmware, select '*firmware upgrade*' from the router's system maintenance menu and select the correct file. Ensure that you select the ALL file unless you want to wipe out your router's settings back to factory default.

It is recommended that you take a configuration backup prior to upgrading the firmware. This can be done from the router's system maintenance menu.
