## Release Notes for DrayTek Vigor 2926 series (UK/Ireland)

Firmware Version	3.9.4.1 (Formal Release)
Release Type	<b>Regular</b> – Upgrade recommended when convenient
Build Date	11 <sup>th</sup> August 2020
Release Date	2 <sup>nd</sup> September 2020
Revision	92671
Applicable Models	Vigor2926, Vigor2926n, Vigor2926ac
Locale	UK & Ireland Only

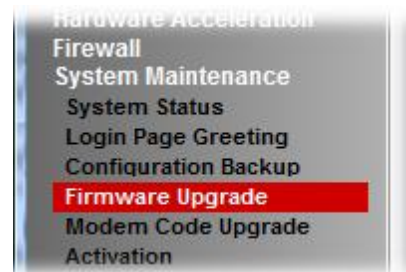
To upgrade firmware, select '*firmware upgrade*' from the router's system maintenance menu and select the correct file. Ensure that you select the ALL file unless you want to wipe out your router's settings back to factory default.
