Release Notes for DrayTek Vigor 2926 series (UK/Ireland)

Firmware Version	3.9.0 (Formal Release)
Release Type	Regular – Upgrade recommended when convenient
Build Date	30 th November 2018
Release Date	2 nd January 2019
Revision	78123
Applicable Models	Vigor2926, Vigor2926n, Vigor2926ac
Locale	UK & Ireland Only

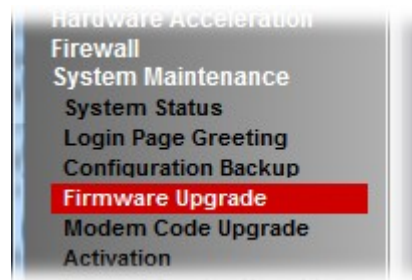
To upgrade firmware, select '*firmware upgrade*' from the router's system maintenance menu and select the correct file. Ensure that you select the ALL file unless you want to wipe out your router's settings back to factory default.
