## Release Notes for DrayTek Vigor 2926 series (UK/Ireland)

Firmware Version	3.9.6.1 (Formal Release)
Release Type	<b>Regular</b> – Upgrade recommended when convenient
Build Date	29 <sup>th</sup> April 2021
Release Date	03 <sup>rd</sup> June 2021
Revision	7506_602_a107ef7
Applicable Models	Vigor2926, Vigor2926n, Vigor2926ac
Locale	UK & Ireland Only

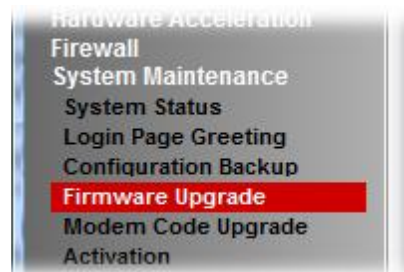
To upgrade firmware, select '*firmware upgrade*' from the router's system maintenance menu and select the correct file. Ensure that you select the ALL file unless you want to wipe out your router's settings back to factory default.
