Release Notes for DrayTek Vigor 2926 series (UK/Ireland)

Firmware Version	3.9.8.1 (Formal Release)
Release Type	Regular – Upgrade recommended when convenient
Build Date	26 th April 2022
Release Date	20 th May 2022
Revision	12433_959_e14180a37
Applicable Models	Vigor2926, Vigor2926n, Vigor2926ac
Locale	UK & Ireland Only

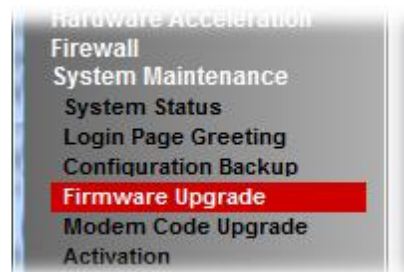
To upgrade firmware, select '*firmware upgrade*' from the router's system maintenance menu and select the correct file. Ensure that you select the ALL file unless you want to wipe out your router's settings back to factory default.
