Release Notes for DrayTek Vigor 3220 (UK/Ireland)

| Firmware Version | 3.9.1.2 (Formal Release) |
| Applicable Models | Vigor 3220 |

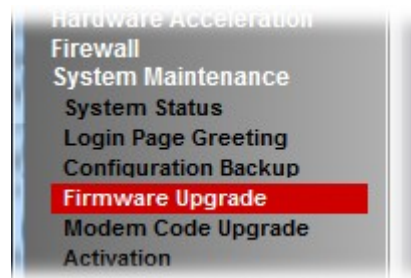
To upgrade firmware, select '*firmware upgrade*' from the router's system maintenance menu and select the correct file. Ensure that you select the ALL file unless you want to wipe out your router's settings back to factory default.
