Release Notes for DrayTek Vigor 3220 (UK/Ireland)

Firmware Version	3.9.7 (Formal Release)
Release Type	Regular – Upgrade recommended when convenient
Build Date	21 st December 2021
Release Date	13 th January 2022
Revision	11307_870_60f8f7d416
Applicable Models	Vigor 3220
Locale	UK Only

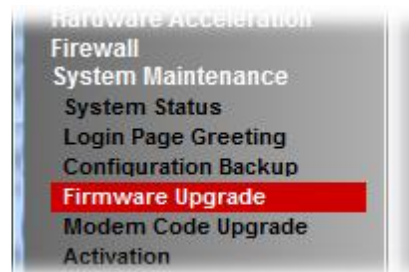
To upgrade firmware, select '*firmware upgrade*' from the router's system maintenance menu and select the correct file. Ensure that you select the ALL file unless you want to wipe out your router's settings back to factory default.
