Release Notes for DrayTek Vigor 3910 (UK/Ireland)

Firmware Version	4.3.1.1 – Mainline branch (Preview Release)
Release Type	Regular – Upgrade recommended when convenient
Build Date	19 th April 2022
Release Date	26 th May 2022
Revision	146_3126_869f846
Applicable Models	Vigor 3910
Locale	UK & Ireland Only

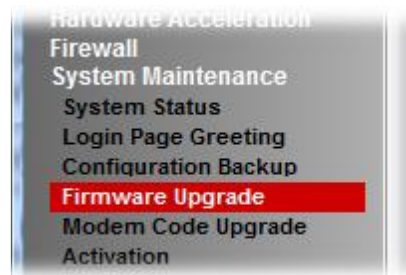
To upgrade firmware, select '*firmware upgrade*' from the router's system maintenance menu and select the correct file. Ensure that you select the ALL file unless you want to wipe out your router's settings back to factory default.
