## Release Notes for DrayTek Vigor 3910 (UK/Ireland)

Firmware Version	4.3.2.5 – Mainline branch (Formal Release)
Release Type	<b>Regular</b> – Upgrade recommended when convenient
Build Date	28 <sup>th</sup> September 2023
Release Date	3 <sup>rd</sup> November 2023
Revision	350_4073_196e127
Applicable Models	Vigor 3910
Locale	UK & Ireland Only

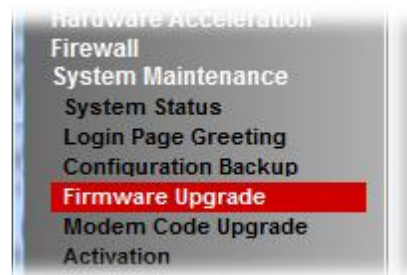
To upgrade firmware, select '*firmware upgrade*' from the router's system maintenance menu and select the correct file. Ensure that you select the ALL file unless you want to wipe out your router's settings back to factory default.
