## **Release Notes for DrayTek VigorAP 910C (UK/Ireland)**

Firmware Version	1.2.7
Release Type	<b>Regular</b> – Upgrade recommended when convenient
Release Date	31 <sup>st</sup> October 2018
Build Date	16 <sup>th</sup> October 2018
Revision	9351
Applicable Models	VigorAP 910C
Locale	UK Only

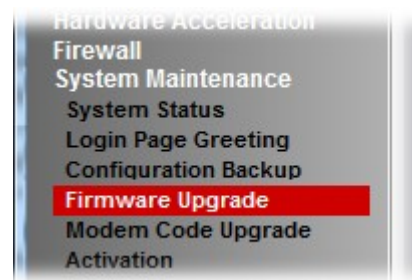
To upgrade firmware, select '*firmware upgrade*' from the AP's system maintenance menu and select the correct file. The access point will perform the upgrade and automatically reboot once this completes.
