Release Notes for DrayTek VigorAP 903 (UK/Ireland)

Firmware Version	1.4.2 (Formal Release)
Release Type	Regular – Upgrade recommended when convenient
Release Date	02 nd August 2021
Build Date	10 th June 2021
Revision	g594_b778c849ea
Applicable Models	VigorAP 903
Locale	UK Only

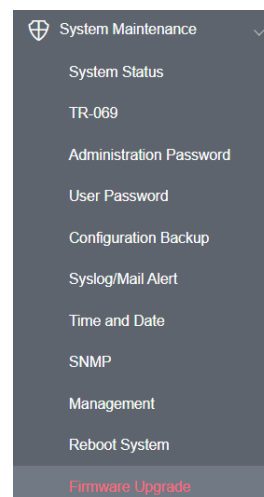
It is recommended that you take a configuration backup prior to upgrading the firmware. This can be done from the AP’s system maintenance menu.

To upgrade firmware, select '*firmware upgrade*' from the AP’s system maintenance menu and select the correct file. The access point will perform the upgrade and automatically reboot once this completes.
